Soils and Foundations

# The damage to hillside embankments in Sendai city during The 2011 off the Pacific Coast of Tohoku Earthquake

Tomohiro Mori<sup>a,\*</sup>, Yoshio Tobita<sup>b</sup>, Takashi Okimura<sup>c</sup>

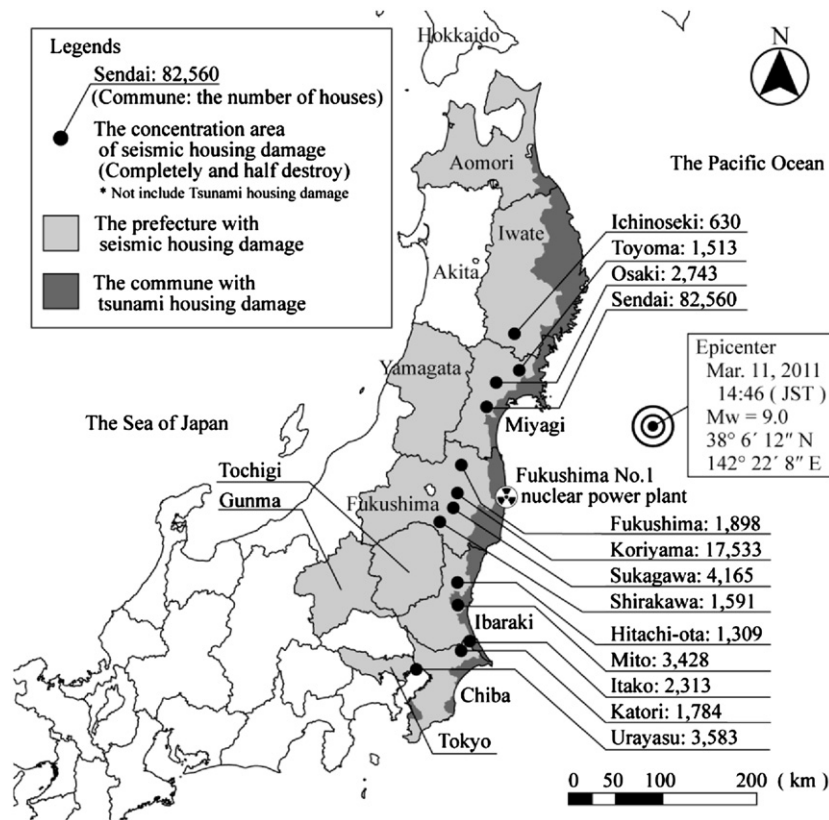
Fig. 1. Damaged area and the number of seismic housing damage in representative commune.

The damage to housing may be classified into tsunami-related damage, damage due to liquefaction of sandy ground on newly reclaimed land, and that caused by the instability of slopes and fill embankments developed for residential use. There was a huge number of damaged houses due to the tsunami, as shown in Fig. 1. The housing damages due to tsunami and due to liquefaction will be discussed elsewhere in this special issue. The focus of this paper is the damage done to housing lots on hillside embankments.

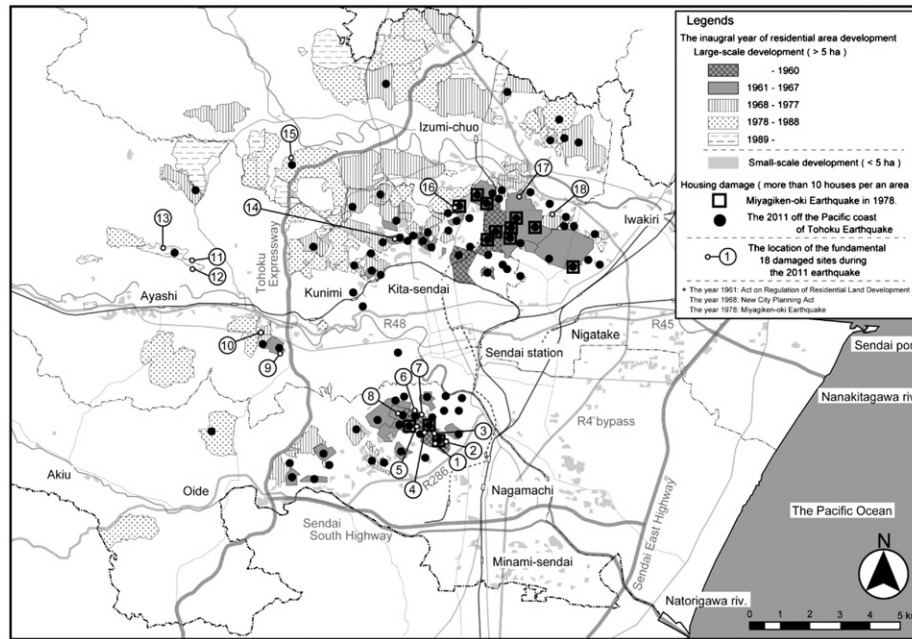
Fig. 5. Developed era of residential area, and damaged area in the 1978 earthquake and the 2011 earthquake.

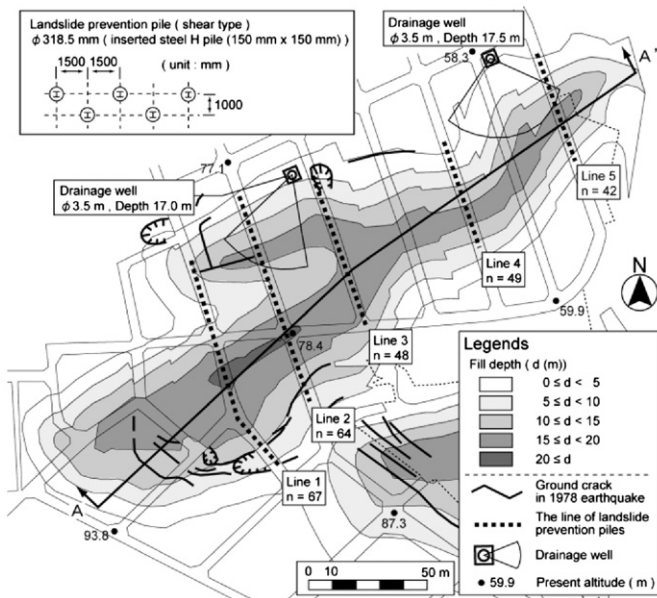
Fig. 6. Plan view on ground damages and countermeasures of Midorigaoka-3-choume in 1978.

Midorigaoka 3 choume is a hillside embankment for residential use which suffered severe damage during the 2011 earthquake. It is located 3 km south-west of the JR Sendai station (numbered as 2 in Fig. 5; “choume” means a numbered subdivision of an area). The residential land had previously suffered enormous damage due to landslide type failure during the 1978 earthquake, which apparently occurred along the boundary between the fill embankment and the original ground. After the 1978 earthquake, 427 restraining piles 32 cm in diameter and 16–25 m in length were placed into the original ground in 5 rows in a zigzag fashion almost vertical to the slope movement and two groundwater drainage wells were constructed. The arrangements are shown in Fig. 6 (see also Photo 1). The housing lots in Midorigaoka 3 choume suffered serious damage again during the 2011 earthquake despite the countermeasures taken after the 1978 earthquake.

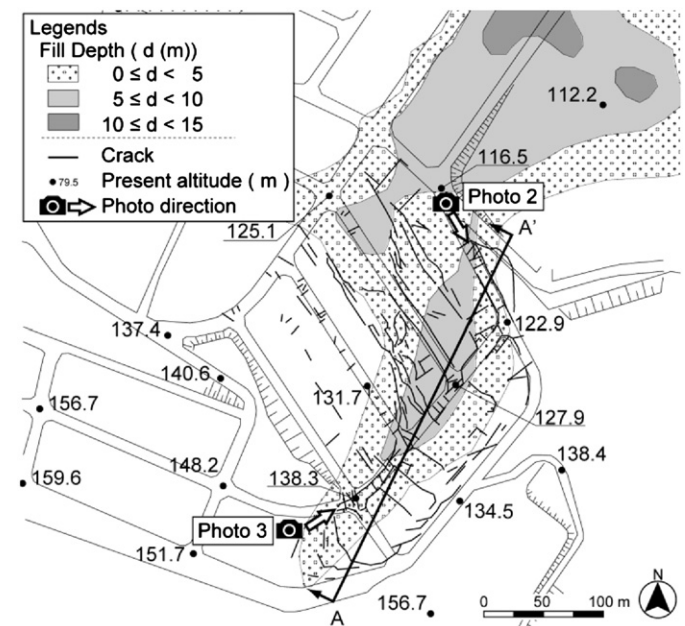
Fig. 9. Plan view of Oritate-5-choume.

Oritate residential land is located (numbered as 9 in Fig. 5) 8 km west of downtown of Sendai city. Ground for housing was started to be created in 1965 and completed in 1972. No damage occurred at this site during the 1978 earthquake. A lot of housing lots and houses suffered serious damages during the 2011 earthquake in this site on a valley filled embankment. Figs. 9 and 10 show the plan and cross section views of this site. The angle of inclination of hillside embankment was from 6° to 8°. The fill material

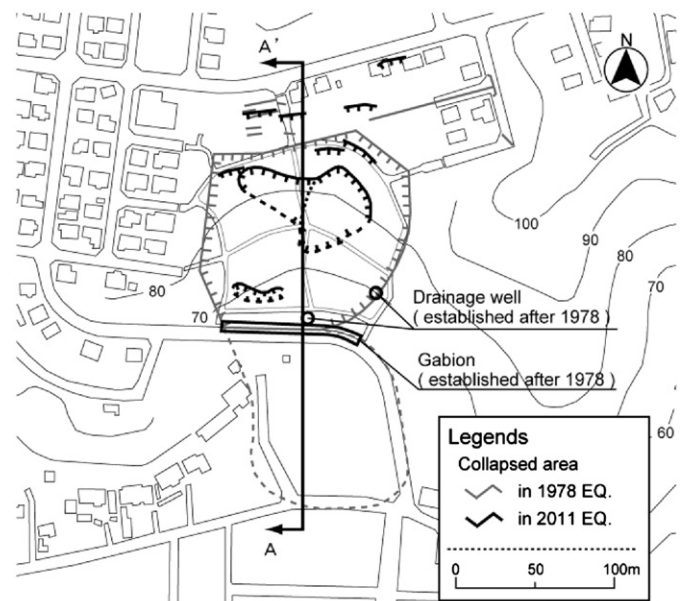
Fig. 17. Plan view of Midorigaoka residential land (Kotobukiyama).

This Midorigaoka land in Shiroishi city is located 35 km southeast of Sendai city. The creation of fill embankment for residential use started in 1972 and was completed in 1978. No houses had been built on the land at the time of the 1978 earthquake. The bedrock of the land was tuff (hard volcanic rock composed of compacted ash). Crushed rock was used as fill materials. The water table was shallow and the water content of the fill embankment was high because of heavy rain prior to the earthquake. The SPT  $N$  values of the fill embankment before the 1978 were reported to be between 5 and 13. The valley filled embankment was severely damaged and flowed downward about 100 m, with a run-off volume estimated at 80,000 m<sup>3</sup> (Figs. 17 and 18).

Fig. 18 shows the cross sections of the damaged fill embankment after the 1978 earthquake along the line A–A' in Fig. 17. The fill depth amounted to 25 m at the top of the slope and the maximum slope angle was 23°. The shallow groundwater table was partly due to filling over a pond. After the collapse as the result of the 1978 earthquake, the fill embankment was re-filled with a slope angle of 10° with a drainage system consisting of a stone filled net and two water collection wells constructed at the

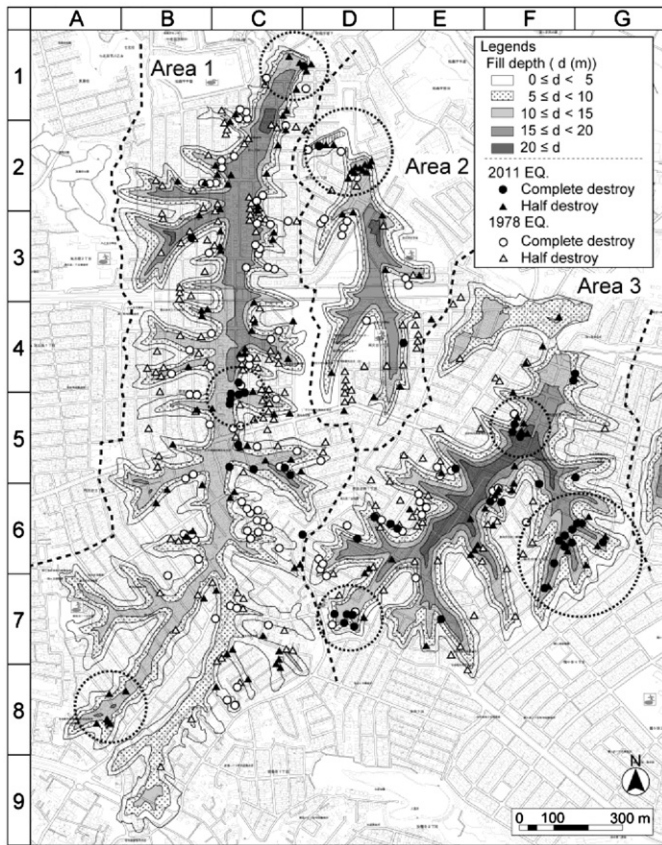
The distribution of completely and half destroyed houses is indicated by black circles and black triangles for the 2011 earthquake and by white dots and white triangles for the 1978 earthquake in Fig. 19. In this figure, the horizontal axis is divided into 6 sections from A to F and the vertical axis is divided into 9 sections from 1 to 9 to indicate the location of the damage. At this site, there are three main valleys. These valleys will be

Fig. 19. Comparison of seismic house damages during the 1978 earthquake with those during the 2011 earthquake (Nankodai area). The Cut-Fill map (background map) was created by Fukken Technical Consultant (2010).

referred as Areas 1–3 from left to right for convenience. The housing damage was more severe on the fill part and along the boundary between fill and cut, and little damage occurred on cut part. It should be noted that a comparison of the damage incurred by the two earthquakes at this site indicates an increase in housing damage due to the slope failure of the fill embankment corresponding to the end of the valley in the original topography in C-1 and D-2. It should also be noted that houses at the uppermost section of the valley were more severely damaged during the 2011 earthquake, located at A-8, D-7, F-6 and G-6. On the other hand, the amount of damage to houses appeared to decrease in the branch valley. In Area 3 the damage to housing on the fill embankment with a maximum fill depth appears to increase, as is the case in F-5, which is the opposite tendency to that in B-4 and C-6.

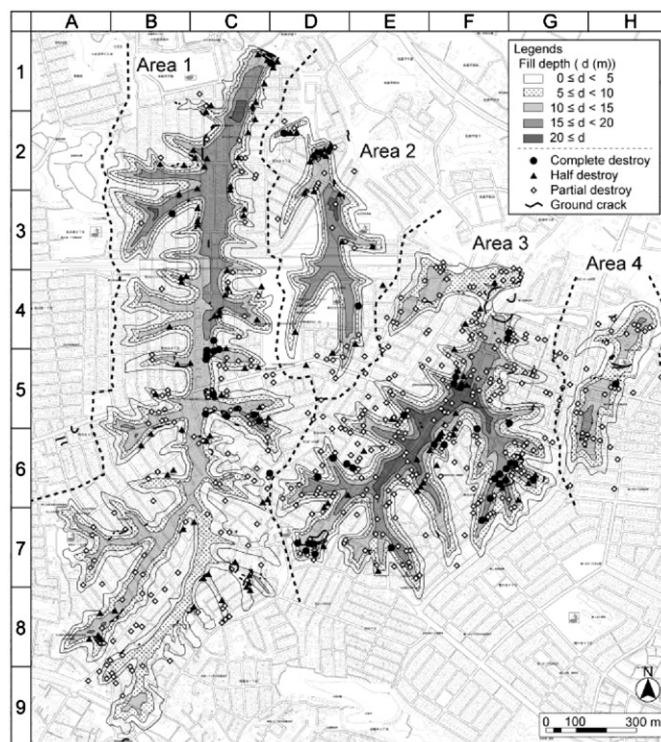
Fig. 20 shows the distribution of damaged houses and ground cracks. Table 2 shows the number of damaged houses, divided into three categories: completely destroyed, half destroyed, and partially destroyed. The completely and half destroyed house are not suitable for residence. However, it is possible to reside in partially destroyed

Fig. 20. Distribution of damaged houses in Nankodai area during the 2011 earthquake.

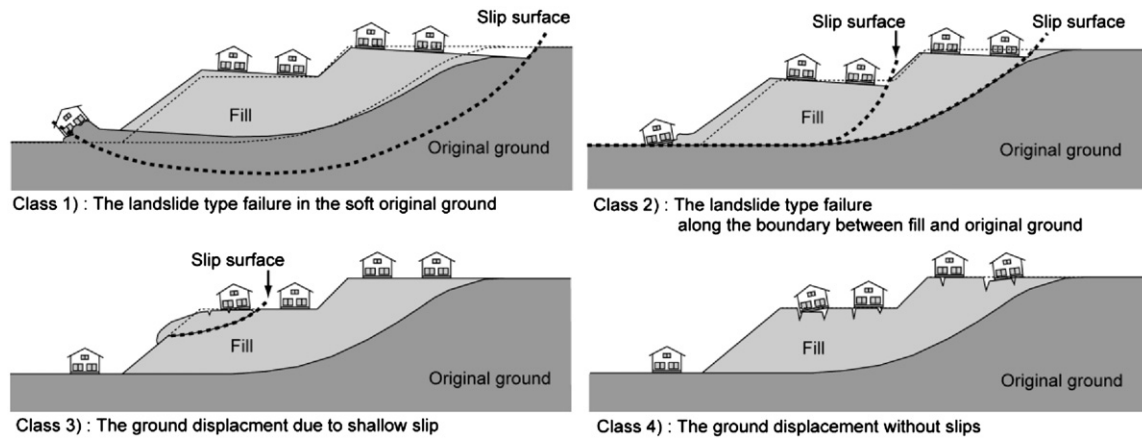
Fig. 21. Schematic figures for the tentative classification of failure type discussed in Table 5.
